Intel® Pentium® 4 Processor on 90 nm Process

Specification Update

March 2006

Document Number: 302352-027

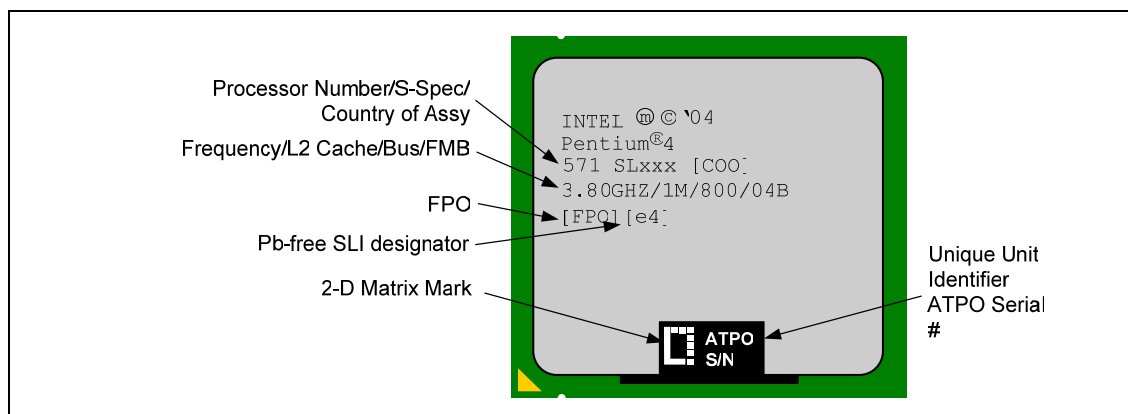
Figure 3. Intel® Pentium® 4 Processors 571, 561, 551, 541, 531 and 521^A Supporting Hyper-Threading Technology on 90 nm Process in the 775-Land LGA Package

| Revision Number | Description | Date |
|---|---|---|
| -025 | <ul style="list-style-type: none"> Updated erratum R17 and added errata R111-R114, updated processor identification table, updated figure 3 and figure 4 to show Pb-free marking | January 2006 |
